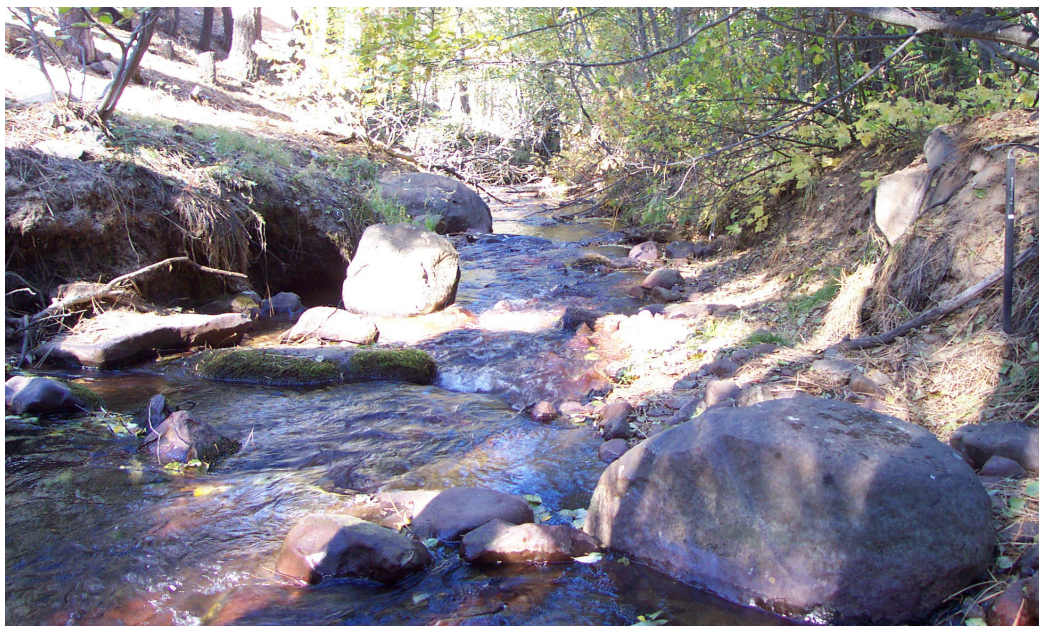
**Figure 4-40. Lack of vegetation increases potential for erosion on the left bank along the urbanized reach of Incline Creek.**

The lower urbanized reach has a greater number of streambank exposures and there are two apparent reasons. Firstly, the channel becomes progressively larger downstream until the banks are higher in places than the depth of plant roots. Secondly, removal or alterations to vegetation in the riparian zone have created short reaches where the banks have been left with inadequate root support. However these areas are infrequent making the overall fine sediment availability rating of the channel low.
